**Flood Control Project Maintenance  
Levee Inspections**

**Maintenance Issue Types Only, Levee Inspection Report By Mile - Fall 2019**

**Reclamation District No. 0349 Sutter Island**

Waterway	Bank	Unit Miles	Inspection Start/End	Inspector
Unit No. 01 Sacramento River	Right	1.59	10/23/2019 10/23/2019	David Julian

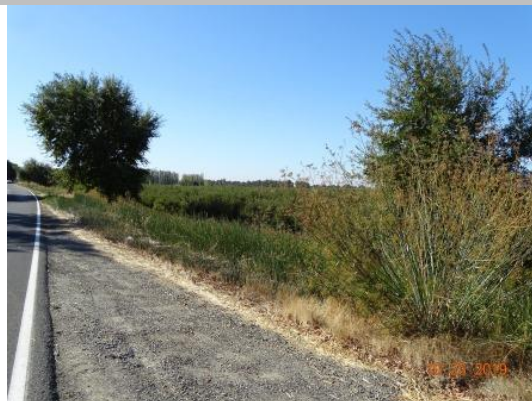
Photo 1 of 1 : FA\_2019\_RD0349\_204\_11\_20191025\_00031.jpg

View looking downstream at thick vegetation on the landside slope (Fall 2019).

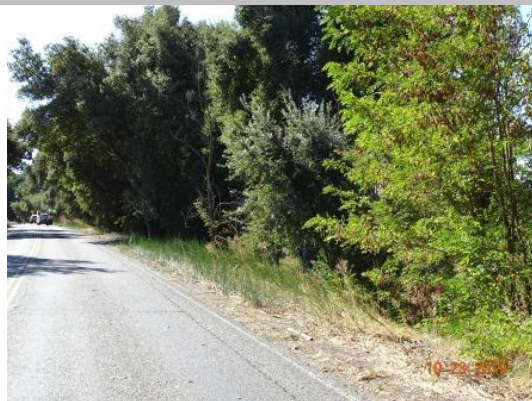
Photo 1 of 1 : FA\_2019\_RD0349\_204\_23\_20191025\_00032.jpg

View looking downstream at thick vegetation on the landside slope (Fall 2019).

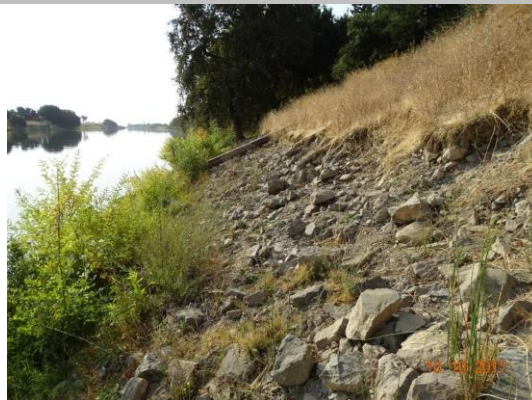
Photo 1 of 1 : FA\_2019\_RD0349\_204\_15\_20190826\_00002.jpg

Item	2017 Storm Damage			38.312911 °	38.312131 °
				-121.578528 °	-121.578292 °
DWR ID	LMA-145				
Comment Code					
Inspector Comment					
<p>Levee Evaluation Comments</p> <p>Description: District Station 52+92 to 55+88, Sec. 06, T. 5 N. R. 4 E., M.D.M. Approximately 296 linear-feet of eroded area exists along the waterside levee slope of the Sacramento River (Unit 1). Erosion commences at approximately 3/4 of the way down the slope from the crown and extends into the rip rap. Some rip rap has been pulled off in this section.</p> <p>Site ID No: 318</p> <p>Site Designation: LMA-145</p> <p>Repair Type: Erosion</p> <p>Rating: Area of Concern</p> <p>Field Date: 7/28/2017</p> <p>Notes: slope too steep, vegetation too thick for clear inspection, no direct visual of damage</p>

Waterside erosion at LM 1.02.

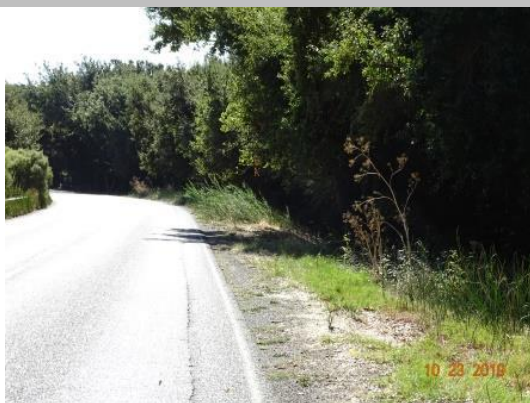
Photo 1 of 1 : FA\_2019\_RD0349\_204\_25\_20191025\_00034.jpg

View looking downstream at vegetation on the landside slope (Fall 2019).

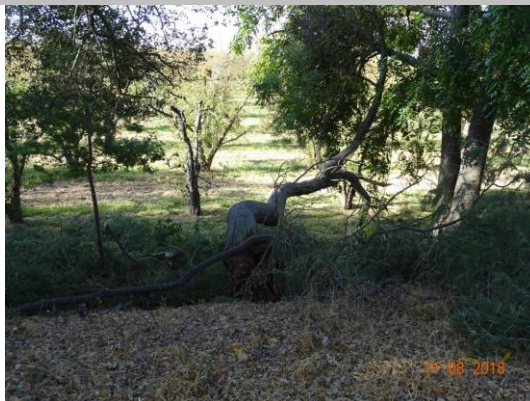
Photo 1 of 1 : FA\_2019\_RD0349\_204\_36\_20190826\_00012.jpg

View of fallen tree limb on the landside toe (November 2018).

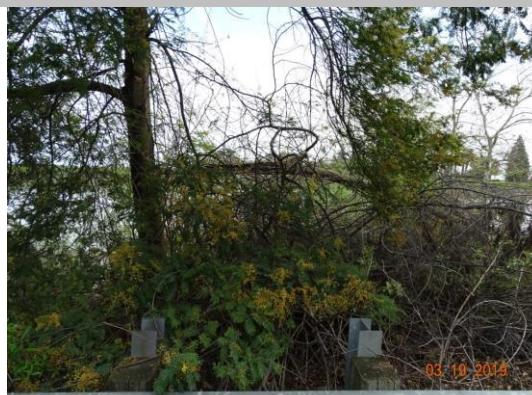
Photo 1 of 1 : FA\_2019\_RD0349\_204\_16\_20190826\_00003.jpg

View of thick trees on the waterside slope (Spring 2019).

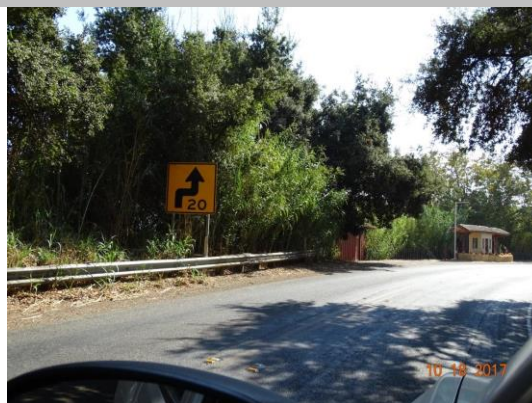
Photo 1 of 1 : FA\_2019\_RD0349\_204\_34\_20190826\_00010.jpg

LM Start	1.54	Rating **	U	Issue No.	34
LM End	1.58	Issue Type +	Ma	Location *	WS
Category	Earthen Levee			GPS Latitude/Longitude	
				Start	End
Item	Vegetation			38.305772 °	38.305252 °
				-121.574763 °	-121.574791 °
DWR ID	DWR_RD0349_01_f_2017_34				
Comment Code					
V2 : Remove the wild growth other than native grasses from the levee slopes.					
Inspector Comment					
Arundo completely blocks visibility and access to waterside of levee.

View of arundo on the waterside of levee

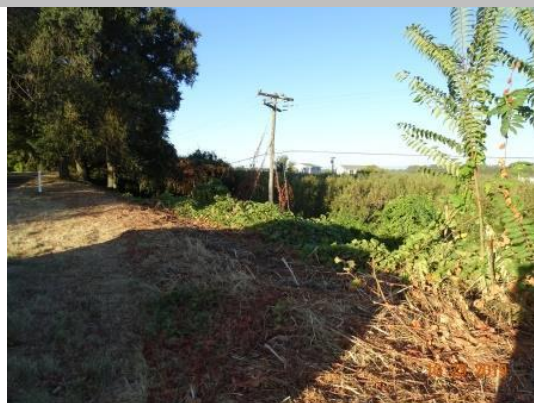
Photo 1 of 1 : FA\_2019\_RD0349\_205\_32\_20191025\_00118.jpg

View looking downstream at vegetation on the landside slope (Fall 2019).

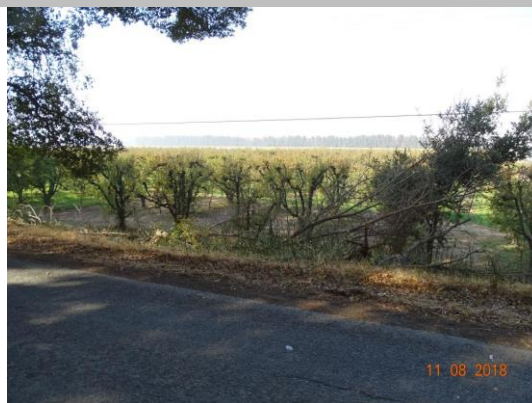
Photo 1 of 1 : FA\_2019\_RD0349\_205\_75\_20190826\_00051.jpg

View of downed tree on the landside slope (November 2018).

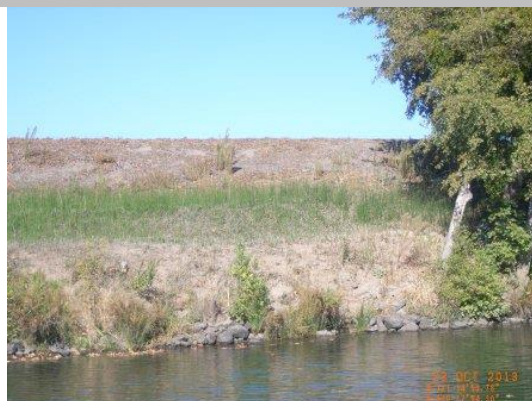
Photo 1 of 1 : FA\_2019\_RD0349\_205\_28\_20190826\_00013.jpg

LM Start	0.60	Rating **	M	Issue No.	28
LM End	0.72	Issue Type +	Ma	Location *	WS
Category	Supplemental			GPS Latitude/Longitude	
				Start	End
Item	2017 USACE Erosion Survey			38.298897 °	38.297384 °
				-121.581571 °	-121.582176 °
DWR ID	DWR_RD0349_02_f_2018_28				
Comment Code					
Inspector Comment					
2017 Site ID: STM 25.5 R					
Status: Eroding					
2017 Field Notes: No observed change.					
Site History: 2010 - Small maintenance, erosion into the toe. 2011 -					
Minor new erosion at toe. 2015 - Minor new erosion at toe, new tree					
pop-out. 2016 - Fresh scarp at downstream end.

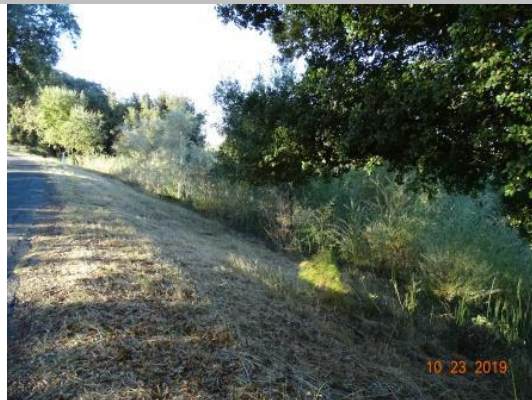
Photo 1 of 1 : FA\_2019\_RD0349\_205\_78\_20191025\_00123.jpg

View looking downstream at thick vegetation on the landside slope (Fall 2019).

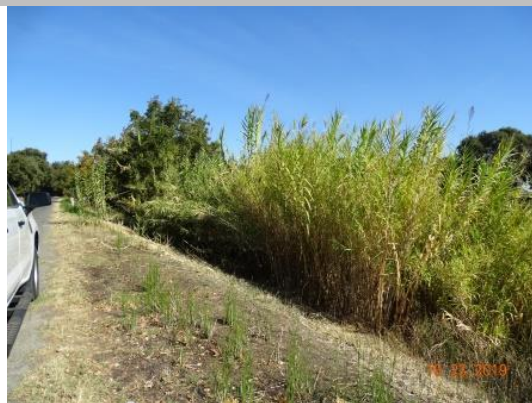
Photo 1 of 1 : FA\_2019\_RD0349\_205\_71\_20191025\_00137.jpg

View looking upstream at arundo on the waterside slope (Fall 2019).

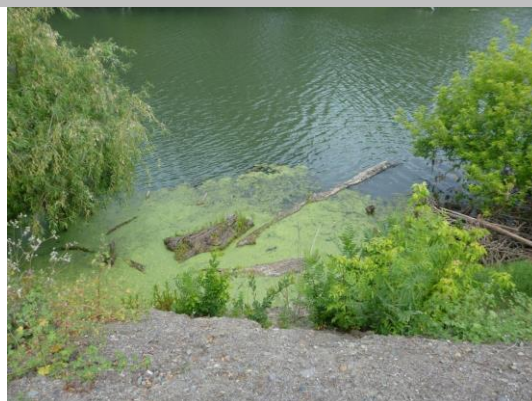
Photo 3 of 3 : FA\_2019\_RD0349\_205\_40\_20190826\_00026.jpg

LM Start	1.33	Rating **	M	Issue No.	40 (cont)	
LM End	1.49	Issue Type +	Ma	Location *		
Category	Supplemental			GPS Latitude/Longitude		
				Start		End
Item	2017 Storm Damage			38.288727 °		38.286475 °
				-121.583823 °		-121.585026 °
DWR ID	DWR_RD0349_02_s_2012_28					
Comment Code						
Inspector Comment						
Levee Evaluation Comments						
Description:						
Site ID No:66						
Site Designation:DWR_RD0349_02_s_2012_28						
Repair Type: Erosion						
Rating:Area of Concern						
Field Date:6/7/2017						
Notes: dense vegetation and large trees hindered visibility; slope riprap appeared failing in some parts

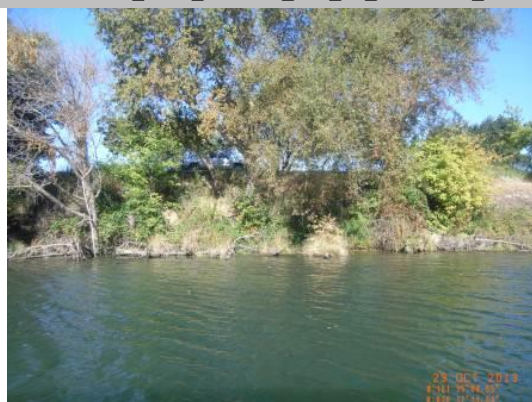
Photo 1 of 1 : FA\_2019\_RD0349\_205\_27\_20190826\_00012.jpg

LM Start	1.33	Rating **	A/W	Issue No.	27
LM End	1.49	Issue Type +	Ma	Location *	WS
Category	Supplemental			GPS Latitude/Longitude	
				Start	End
Item	2017 USACE Erosion Survey			38.288727 °	38.286475 °
				-121.583823 °	-121.585026 °
DWR ID	DWR_RD0349_02_f_2018_27

Comment Code					
Inspector Comment					
2017 Site ID: STM 24.7 R					
Status: Critical					
2017 Field Notes: No observed change.					
Site History: 1997 - Erosion of very sandy levee behind large stand of riparian vegetation on top right bank. Dry ravel of sand. 1999 - Quarry waste rock was dumped down the levee slope; poor repair job; still eroding in places. Eroding at midslope off fabric. 2005 - Length revised, only the middle 150 - 200 ft are eroding. 2006 - Some rock/small material dumped down the bank but it is slowly unraveling. Upstream end is unraveling faster. Steep slope with poor gradation so fines are washing out. 2010 - Lots of overhanging trees and erosion pockets. 2011 - This site is upgraded to CRITICAL. Near vertical bank at the downstream end. New erosion at various locations throughout the site.

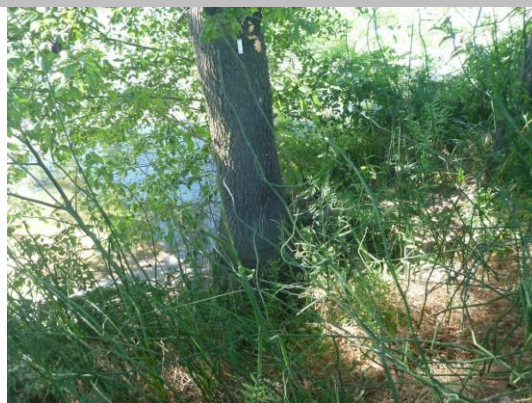
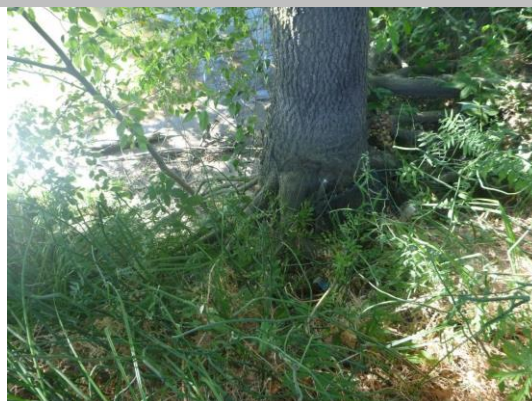
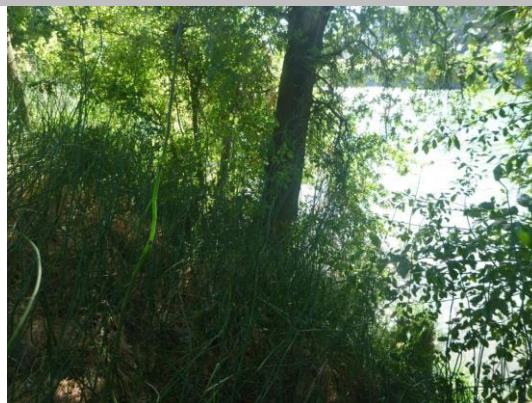
LM Start	<b>1.46</b>	Rating **	A/W	Issue No.	<b>34</b>							
LM End	<b>1.46</b>	Issue Type +	Ma	Location *								
Category	Supplemental		GPS Latitude/Longitude									
			Start	End								
Item	2017 Storm Damage		38.286886 °	38.286861 °								
			-121.584589 °	-121.584622 °								
DWR ID	LMA-149											
Comment Code												
Inspector Comment												
Levee Evaluation Comments Description: District Station 77+56 to 77+68, Sec. 18, T. 5 N. R. 4 E., M.D.M. Approximately 12 linear feet of erosion/sloughing exists along the water side slope of Steamboat Slough (Unit 2). The erosion area commences approximately halfway down the slope from the levee crown and extends to the waterside toe around existing trees. No rip rap is visible in this area. Site ID No: 322 Site Designation: LMA-149 Repair Type: Erosion Rating: Area of Concern Field Date: 7/28/2017 Notes: no berm

LM Start	1.46	Rating **	A/W	Issue No.	34 (cont)	
LM End	1.46	Issue Type +	Ma	Location *		
Category	Supplemental			GPS Latitude/Longitude		
				Start	End	
Item	2017 Storm Damage			38.286886 °	38.286861 °	
				-121.584589 °	-121.584622 °	
DWR ID	LMA-149					
Comment Code						
Inspector Comment						
Levee Evaluation Comments						
Description:District Station 77+56 to 77+68, Sec. 18, T. 5 N. R. 4 E., M.D.M. Approximately 12 linear feet of erosion/sloughing exists along the water side slope of Steamboat Slough (Unit 2). The erosion area commences approximately halfway down the slope from the levee crown and extends to the waterside toe around existing trees. No rip rap is visible in this area.						
Site ID No:322						
Site Designation:LMA-149						
Repair Type: Erosion						
Rating:Area of Concern						
Field Date:7/28/2017						
Notes: no berm

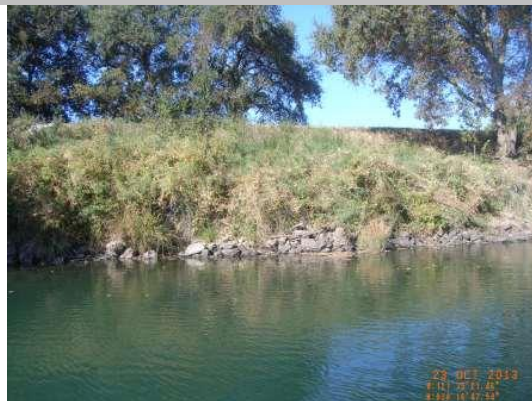
Photo 1 of 1 : FA\_2019\_RD0349\_205\_26\_20190826\_00011.jpg

LM Start	2.04	Rating **	M	Issue No.	26
LM End	2.05	Issue Type +	Ma	Location *	WS
Category	Supplemental			GPS Latitude/Longitude	
				Start	End
Item	2017 USACE Erosion Survey			38.280069 °	38.279919 °
				-121.589443 °	-121.589438 °
DWR ID	DWR_RD0349_02_f_2018_26				
Comment Code					
Inspector Comment					
2017 Site ID: STM 24.1 R					
Status: Eroding					
2017 Field Notes: No observed change.					
Site History: 2011 - Small scallop caused by erosion and wave wash.

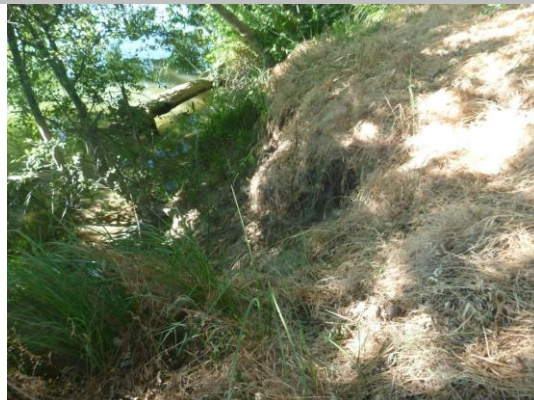
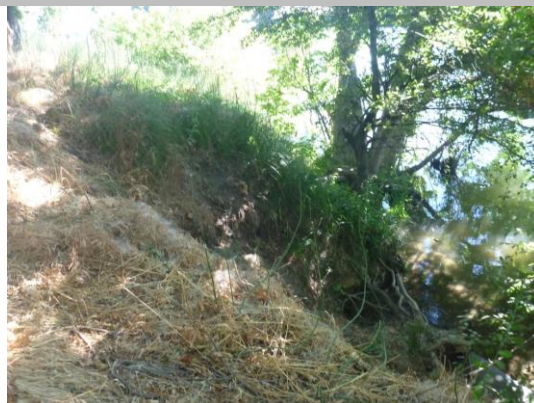
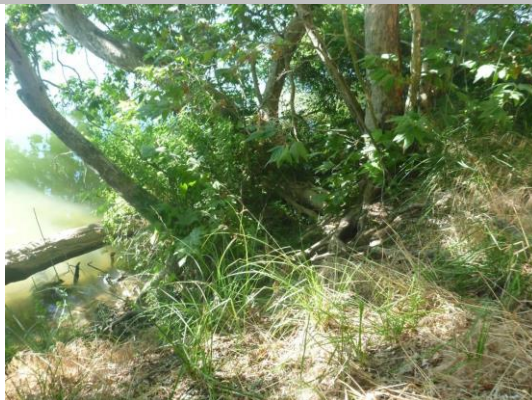
LM Start	2.11	Rating **	A/W	Issue No.	41
LM End	2.13	Issue Type +	Ma	Location *	
Category	Supplemental			GPS Latitude/Longitude	
				Start	End
Item	2017 Storm Damage			38.279039 °	38.278806 °
				-121.589664 °	-121.589783 °
DWR ID	LMA-151				
Comment Code					
Inspector Comment					
Levee Evaluation Comments					
Description:District Station 112+11 to 113+04, Sec. 13, T. 5 N. R. 3 E., M.D.M. Approximately 93 linear feet of erosion exists along the water side slope of Steamboat Slough (Unit 2). The erosion area commences approximately 3/4 of the way down the slope from the levee crown and extends to the waterside toe around existing trees. No rip rap is visible in this area.					
Site ID No:324					
Site Designation:LMA-151					
Repair Type: Erosion					
Rating:Serious					
Field Date:7/28/2017					
Notes: no berm

LM Start	2.11	Rating **	A/W	Issue No.	41 (cont)
LM End	2.13	Issue Type +	Ma	Location *	
Category	Supplemental			GPS Latitude/Longitude	
				Start	End
Item	2017 Storm Damage			38.279039 °	38.278806 °
				-121.589664 °	-121.589783 °
DWR ID	LMA-151				
Comment Code					
Inspector Comment					
Levee Evaluation Comments					
Description:District Station 112+11 to 113+04, Sec. 13, T. 5 N. R. 3 E., M.D.M. Approximately 93 linear feet of erosion exists along the water side slope of Steamboat Slough (Unit 2). The erosion area commences approximately 3/4 of the way down the slope from the levee crown and extends to the waterside toe around existing trees. No rip rap is visible in this area.					
Site ID No:324					
Site Designation:LMA-151					
Repair Type: Erosion					
Rating:Serious					
Field Date:7/28/2017					
Notes: no berm

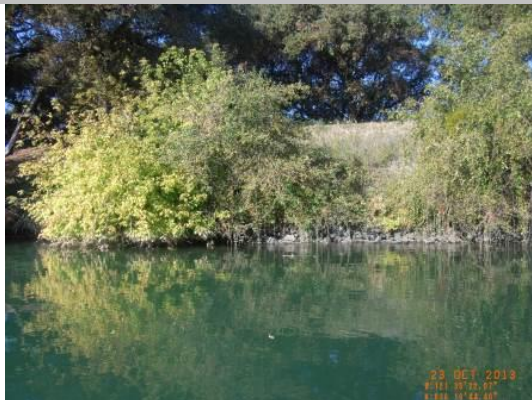
Photo 1 of 1 : FA\_2019\_RD0349\_205\_25\_20190826\_00010.jpg

LM Start	2.11	Rating **	A/W	Issue No.	25
LM End	2.14	Issue Type +	Ma	Location *	WS
Category	Supplemental			GPS Latitude/Longitude	
				Start	End
Item	2017 USACE Erosion Survey			38.279017 °	38.278597 °
				-121.589615 °	-121.589854 °
DWR ID	DWR_RD0349_02_f_2018_25				
Comment Code					
Inspector Comment					
2017 Site ID: STM 23.9 R Status: Eroding 2017 Field Notes: No observed change. Site History: 1997 - Top right bank has retreated into the levee. Site is between two rock sites. 1999 - Downstream half of the reach repaired with rock. 2000 - Trees leaning into the water. 2010 - Site appears worse. 2011 - New erosion at the toe. 2013 - Short vertical sections observed at upstream end. 2015 - Minor new erosion.

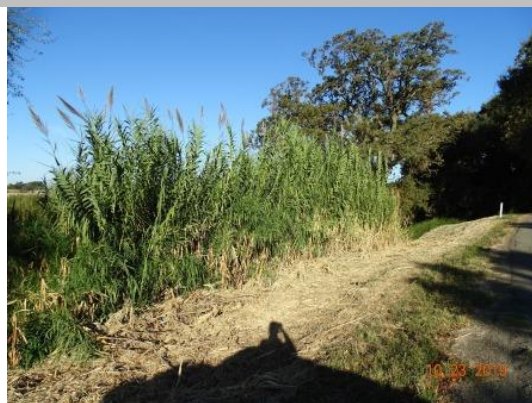
Photo 1 of 1 : FA\_2019\_RD0349\_205\_60\_20191025\_00129.jpg

View looking upstream at arundo on the landside slope (Fall 2019).

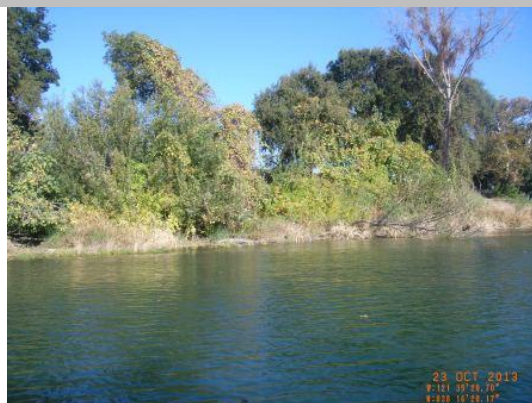
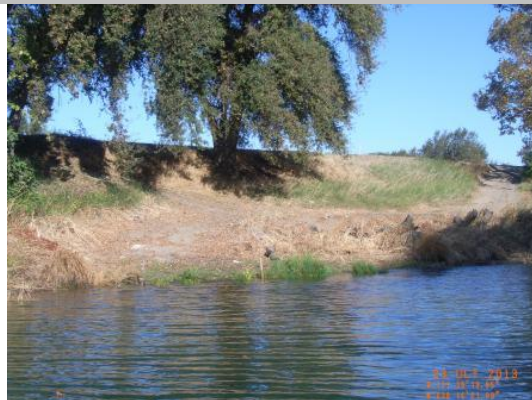
LM Start	2.56	Rating **	A/W	Issue No.	24
LM End	2.69	Issue Type +	Ma	Location *	WS
Category	Supplemental			GPS Latitude/Longitude	
				Start	End
Item	2017 USACE Erosion Survey			38.273854 °	38.271998 °
				-121.588745 °	-121.589424 °
DWR ID	DWR_RD0349_02_f_2018_24				
Comment Code					
Inspector Comment					
2017 Site ID: STM 23.6 R					
Status: Eroding					
2017 Field Notes: Previously observed quarry stone at the downstream end is now gone. Significant erosion at upstream end. Fresh sedimentation on the downstream end.					
Site History: 2011 - Toe scour at the tidal zone. 2015 - New tree pop-out and minor new erosion. 2016 - New erosion at upstream end.

LM Start	2.56	Rating **	A/W	Issue No.	24 (cont)
LM End	2.69	Issue Type +	Ma	Location *	WS
Category	Supplemental			GPS Latitude/Longitude	
				Start	End
Item	2017 USACE Erosion Survey			38.273854 °	38.271998 °
				-121.588745 °	-121.589424 °
DWR ID	DWR_RD0349_02_f_2018_24				
Comment Code					
Inspector Comment					
2017 Site ID: STM 23.6 R					
Status: Eroding					
2017 Field Notes: Previously observed quarry stone at the downstream end is now gone. Significant erosion at upstream end. Fresh sedimentation on the downstream end.					
Site History: 2011 - Toe scour at the tidal zone. 2015 - New tree pop-out and minor new erosion. 2016 - New erosion at upstream end.

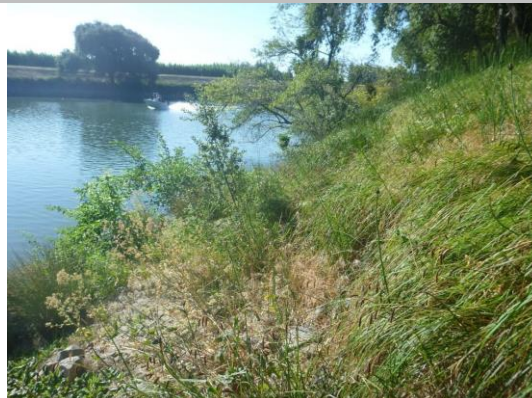
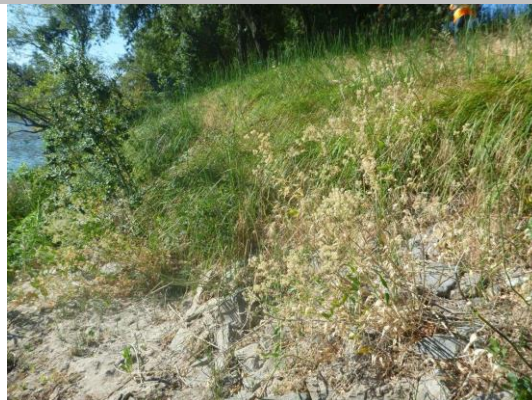
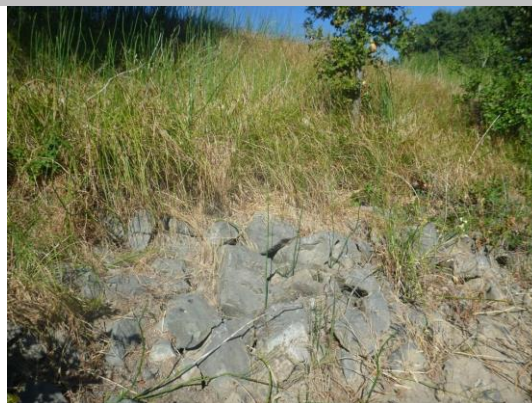
LM Start	2.56	Rating **	A/W	Issue No.	43
LM End	2.59	Issue Type +	Ma	Location *	
Category	Supplemental			GPS Latitude/Longitude	
				Start	End
Item	2017 Storm Damage			38.273769 °	38.273386 °
				-121.588742 °	-121.588672 °
DWR ID	LMA-153				
Comment Code					
Inspector Comment					
Levee Evaluation Comments					
Description:District Station 135+81 to 137+00, Sec. 13, T. 5 N. R. 3 E., M.D.M. Approximately 119 linear feet of sloughing exists due to scour along the water side toe of Steamboat Slough (Unit 2). The erosion area commences approximately 3/4 of the way down the slope from the levee crown and extends to the waterside toe. No rip rap is visible in this area.					
Site ID No:326					
Site Designation:LMA-153					
Repair Type: Erosion					
Rating:Area of Concern					
Field Date:7/28/2017					
Notes: no berm

LM Start	2.56	Rating **	A/W	Issue No.	43 (cont)	
LM End	2.59	Issue Type +	Ma	Location *		
Category	Supplemental			GPS Latitude/Longitude		
				Start	End	
Item	2017 Storm Damage			38.273769 °	38.273386 °	
				-121.588742 °	-121.588672 °	
DWR ID	LMA-153					
Comment Code						
Inspector Comment						
Levee Evaluation Comments						
Description:District Station 135+81 to 137+00, Sec. 13, T. 5 N. R. 3 E., M.D.M. Approximately 119 linear feet of sloughing exists due to scour along the water side toe of Steamboat Slough (Unit 2). The erosion area commences approximately 3/4 of the way down the slope from the levee crown and extends to the waterside toe. No rip rap is visible in this area.						
Site ID No:326						
Site Designation:LMA-153						
Repair Type: Erosion						
Rating:Area of Concern						
Field Date:7/28/2017						
Notes: no berm

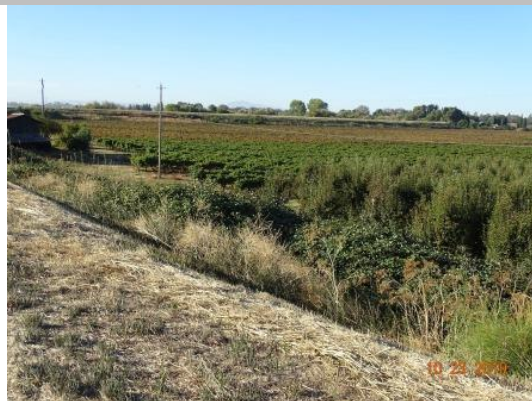
Photo 1 of 1 : FA\_2019\_RD0349\_205\_101\_20191025\_00131.jpg

View looking downstream at thick blackberries at the bottom of the landside slope (Fall 2019).

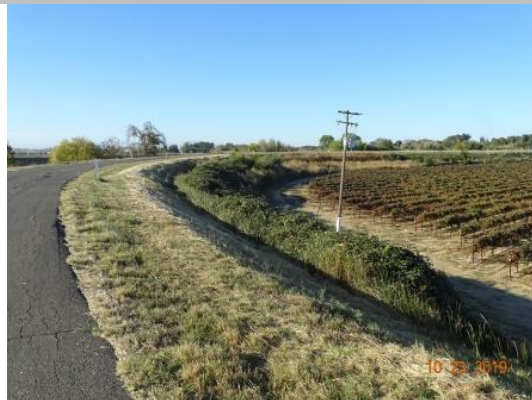
Photo 1 of 1 : FA\_2019\_RD0349\_205\_62\_20191025\_00132.jpg

View looking downstream at thick blackberries on the bottom of the landside slope (Fall 2019).

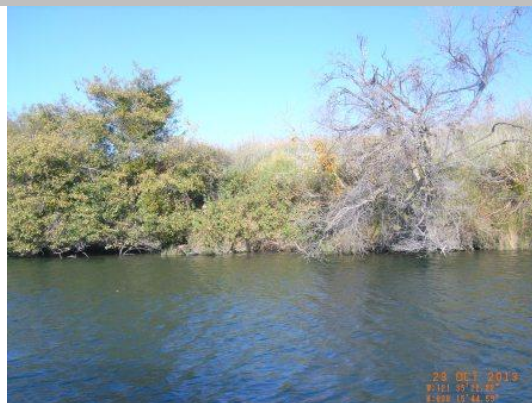
Photo 1 of 1 : FA\_2019\_RD0349\_205\_23\_20190826\_00007.jpg

LM Start	3.38	Rating **	M	Issue No.	23
LM End	3.49	Issue Type +	Ma	Location *	WS
Category	Supplemental			GPS Latitude/Longitude	
				Start	End
Item	2017 USACE Erosion Survey			38.262510 °	38.262533 °
				-121.589481 °	-121.591690 °
DWR ID	DWR_RD0349_02_f_2018_23				
Comment Code					
Inspector Comment					
2017 Site ID: STM 22.8 R					
Status: Eroding					
2017 Field Notes: No observed change.					
Site History: 2010 - Slumping sections on the lower bank, appears to be scouring around the trees. 2011 - Soil beach at toe.

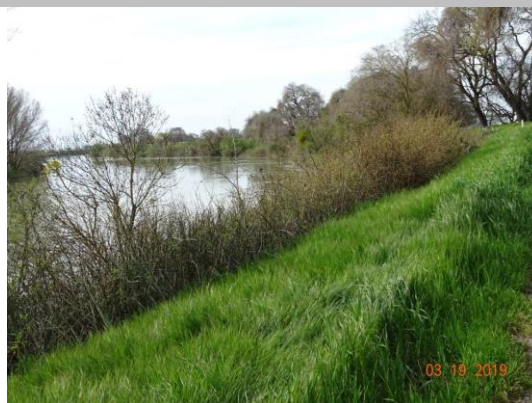
Photo 1 of 1 : FA\_2019\_RD0349\_205\_104\_20190826\_00063.jpg

LM Start	3.64	Rating **	U	Issue No.	104
LM End	3.67	Issue Type +	Ma	Location *	WS
Category	Earthen Levee			GPS Latitude/Longitude	
				Start	End
Item	Vegetation			38.262068 °	38.261835 °
				-121.594283 °	-121.594553 °
DWR ID	DWR_RD0349_02_s_2019_104				
Comment Code					
V2 : Remove the wild growth other than native grasses from the levee slopes.					
Inspector Comment					
Wild growth is blocking the view down the waterside slope.

View looking downstream at wild growth on the waterside slope (Spring 2019).

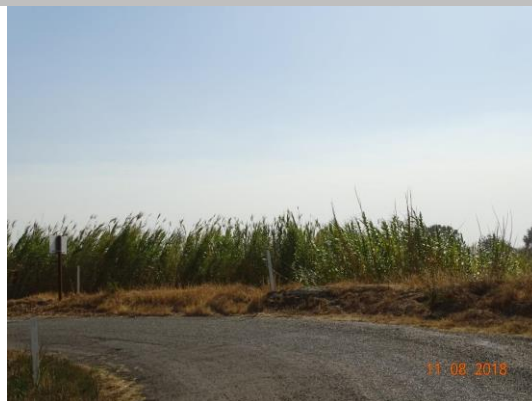
Photo 1 of 1 : FA\_2019\_RD0349\_205\_30\_20190826\_00014.jpg

View of arundo on the waterside slope (November 2018).

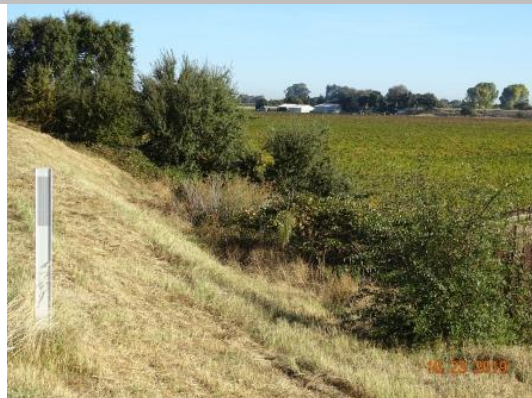
Photo 1 of 1 : FA\_2019\_RD0349\_206\_34\_20191025\_00090.jpg

View looking upstream at vegetation on the landside slope (Fall 2019).

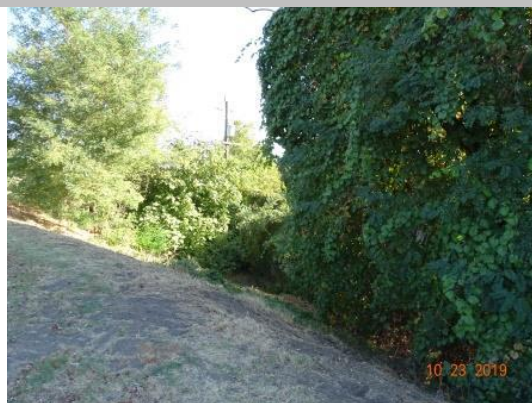
Photo 1 of 1 : FA\_2019\_RD0349\_206\_51\_20191025\_00092.jpg

View looking upstream at untrimmed trees on the landside slope (Fall 2019).

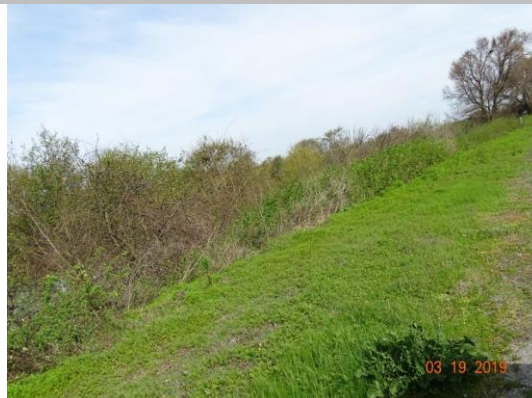
Photo 1 of 1 : FA\_2019\_RD0349\_206\_48\_20190826\_00010.jpg

View looking upstream at thick wild growth within 20 feet of the waterside shoulder (Spring 2019).
